Important patient notice regarding Exactech knee replacement devices

April 7, 2022

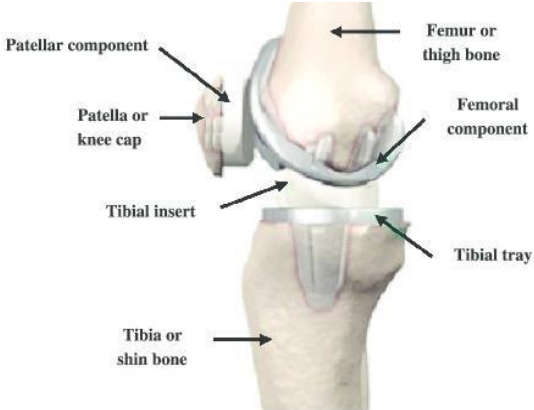
<p>A standard total knee replacement has four parts:</p> <ol style="list-style-type: none">1. The femoral component (this is the metal piece that attaches to your thigh bone, also known as your "femur")2. The tibial tray (this is the metal piece that fits into your shin bone, also known as your "tibia")3. The patellar component (this is the piece of plastic that fits onto your kneecap, also known as the patella)4. The tibial polyethylene (plastic) insert (this is the plastic that fits between the femoral component and tibial component and acts as the new cushion or cartilage for your replaced knee joint)

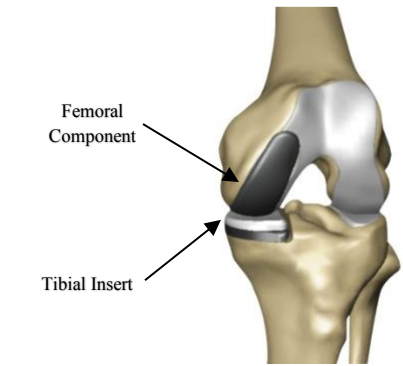
<p>A partial knee replacement has the primary parts illustrated in the figure to the right:</p> <ol style="list-style-type: none">1. The partial femoral component (this is the metal piece that attaches to your thigh bone, also known as your "femur")2. The partial tibial polyethylene (plastic) insert (this is the plastic that fits between the partial femoral component and tibial component and acts as the new cushion or cartilage for your partially replaced knee joint)
